2010 Aircraft Airworthiness & Sustainment
(AA&S) Conference

**40-in. OMS Kevlar® COPV S/N 007 Stress
Rupture Test NDE**

NASA WSTF: Regor Saulsberry
NASA WSTF: Nate Greene
NASA JSC: Scott Forth
Jacobs/WSTF: Mark Leifeste/Tim Gallus/Tommy
Yoder/Chris Keddy
NASA LaRC: Eric Madaras/Buzz Wincheski/Philip Williams
NASA KSC: Richard Russell
NASA GRC: Jeff Eldridge

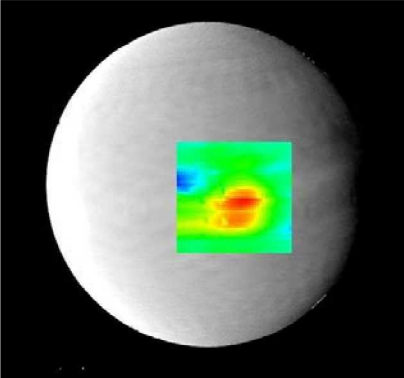
Z axis deformation at this anomaly is greater than adjacent areas of Kevlar wrap by 0.095 $\mu\text{m}/\text{psi}$.

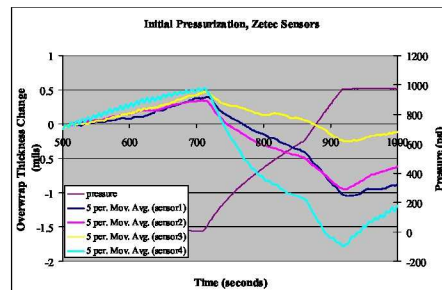
- Three EC sensors (#1 - 3) were placed over the peak of the largest liner ripple indications, and one sensor (#4) was placed in the liner membrane region as a reference.
 - Response of Sensors #1 - 3 was in family with the membrane reference sensor, indicating ripples were not behaving as unstable "buckles" during pressurization
 - Stand-off change of 1 to 2 mils per 1000 psi was consistent with EC data obtained from other 40 in. Kevlar COPV testing

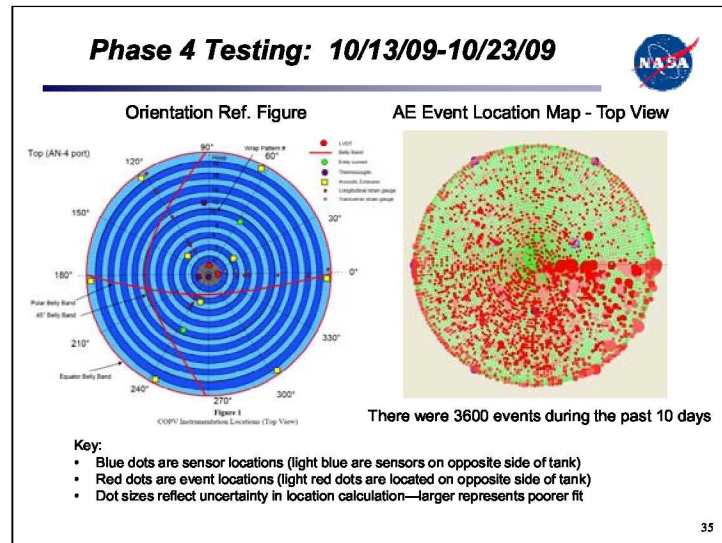
This is a view of all the AE events to date as seen from a top down view. Some event clusters appear near the equator. A few loose groupings near the poles

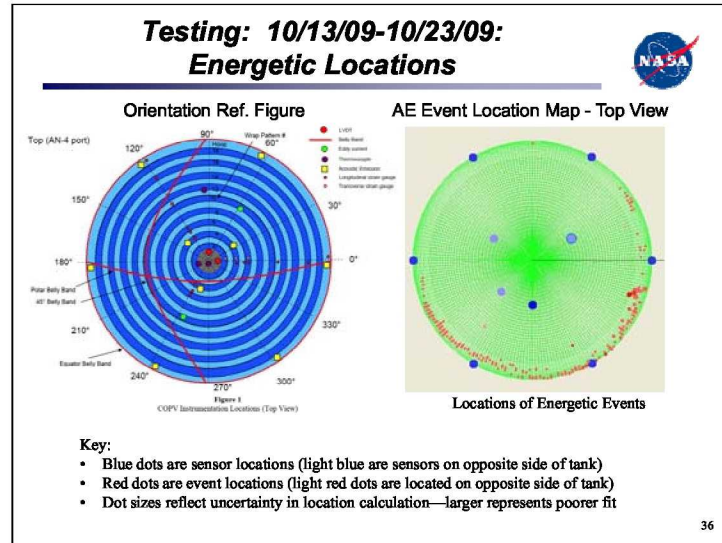
This is a view of all the AE events to date as seen from a top down view. Some event clusters appear near the equator. A few loose groupings near the poles

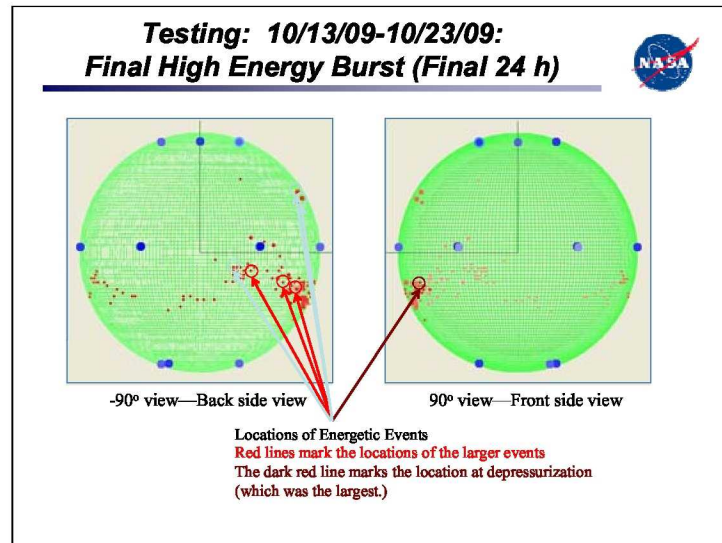
- There were two AE event rate increase periods that occurred during the last 7 days. The last rate increase ended in failure.
 - Over 3000 recorded events during the last 10 days
 - More than 300 very energetic events recorded during the last week
 - The rate increases were coincidental with trains of very large energy signal events.
 - The first rate increase for large energy signal events (24 to 96 hours before the end) was approximately 2/hour.
 - The second and final rate increase for large energy signal events (last 24 hours) was approximately 6/hour.
- Event energies rose to very elevated levels during the last 96 hours.
 - High energy events were > 25 times greater than energetic events in the past.
 - The loudest events occurred at the end (last 24 hours).
 - The final event, which was the loudest, was located ~45° below the equator and near the azimuth angle of 45°.
